# Manhole Inspection Summary

Manhole # S43MM\_018MH

Insp Date: **4/23/08 1:05 PM**

**Location** Address: **Regester St**

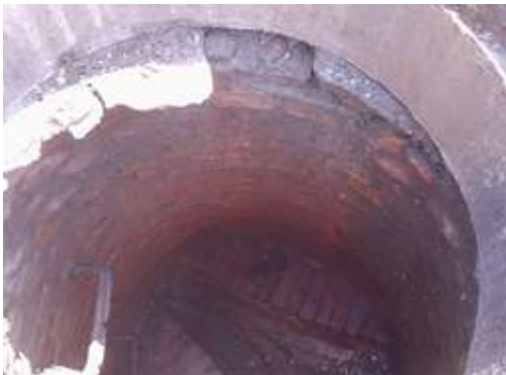
Defect 1

Condition: ☐ Sound ☐ Cracked ☐ Root Intrusion ☒ **Loose Brick** ☒ **Deteriorated**

Deterioration

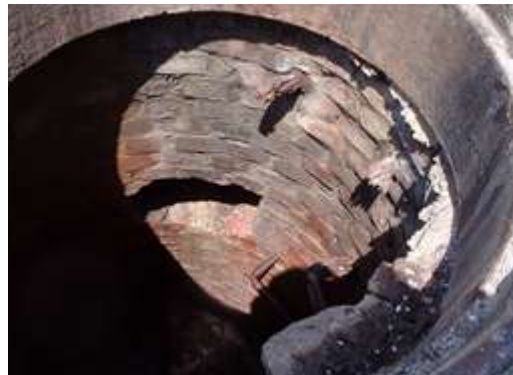
Defect 2

Loose Bricks

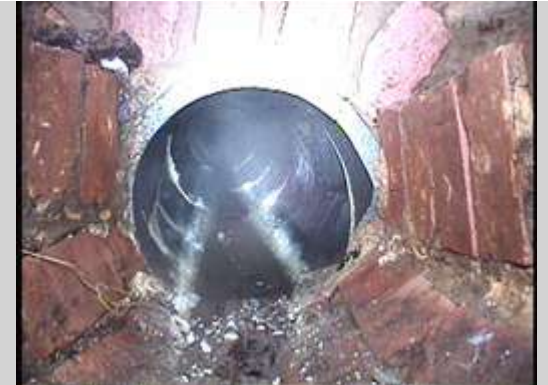
12 O'Clock Outflow

Pipe Height: **8.4** (in.) Rod and Bar (Angled)  
Pipe Material: **Clay** ☐ Pipe Lined  
Invert Depth: **8.30** (ft.) Flow Characteristics: **Slow**  
Deposits: ☒ None ☐ Mud ☐ Sludge ☐ Debris ☐ Grease  
Silt Depth: (in.) Deposits Extent:  
Infiltration: **None** Pipe Seal Cond: **Sound**

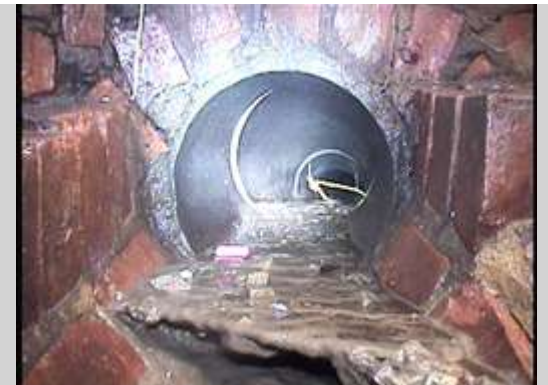
6 O'Clock Inflow

Pipe Height: **8.4** (in.) Rod and Bar (Angled)  
Pipe Material: **Clay** ☐ Pipe Lined  
Invert Depth: **7.50** (ft.) Flow Characteristics: **Slow**  
Deposits: ☒ None ☐ Mud ☐ Sludge ☐ Debris ☐ Grease  
Silt Depth: (in.) Deposits Extent:  
Infiltration: **None** Pipe Seal Cond: **Sound**

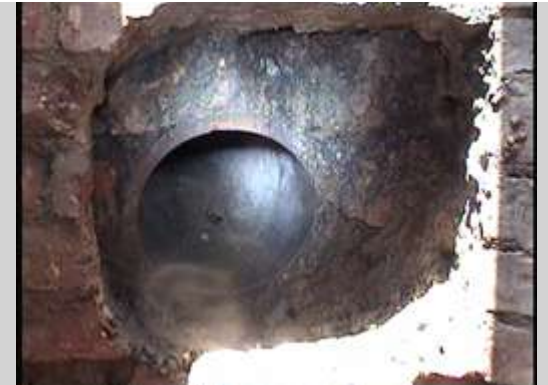
9 O'Clock Inflow

Infiltration: **None** Pipe Seal Cond: **Sound**

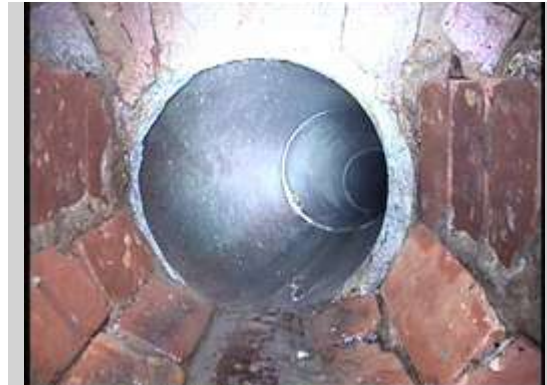
Drop In @ 9 O'Clock

Drop: **Outside** Rod and Bar

Drop Condition: **Open**
